Report No. CG-WEP-2-79

FATE OF OIL SPILLED FROM THE  
SUPERTANKER METULA

JANUARY 1979

FINAL REPORT

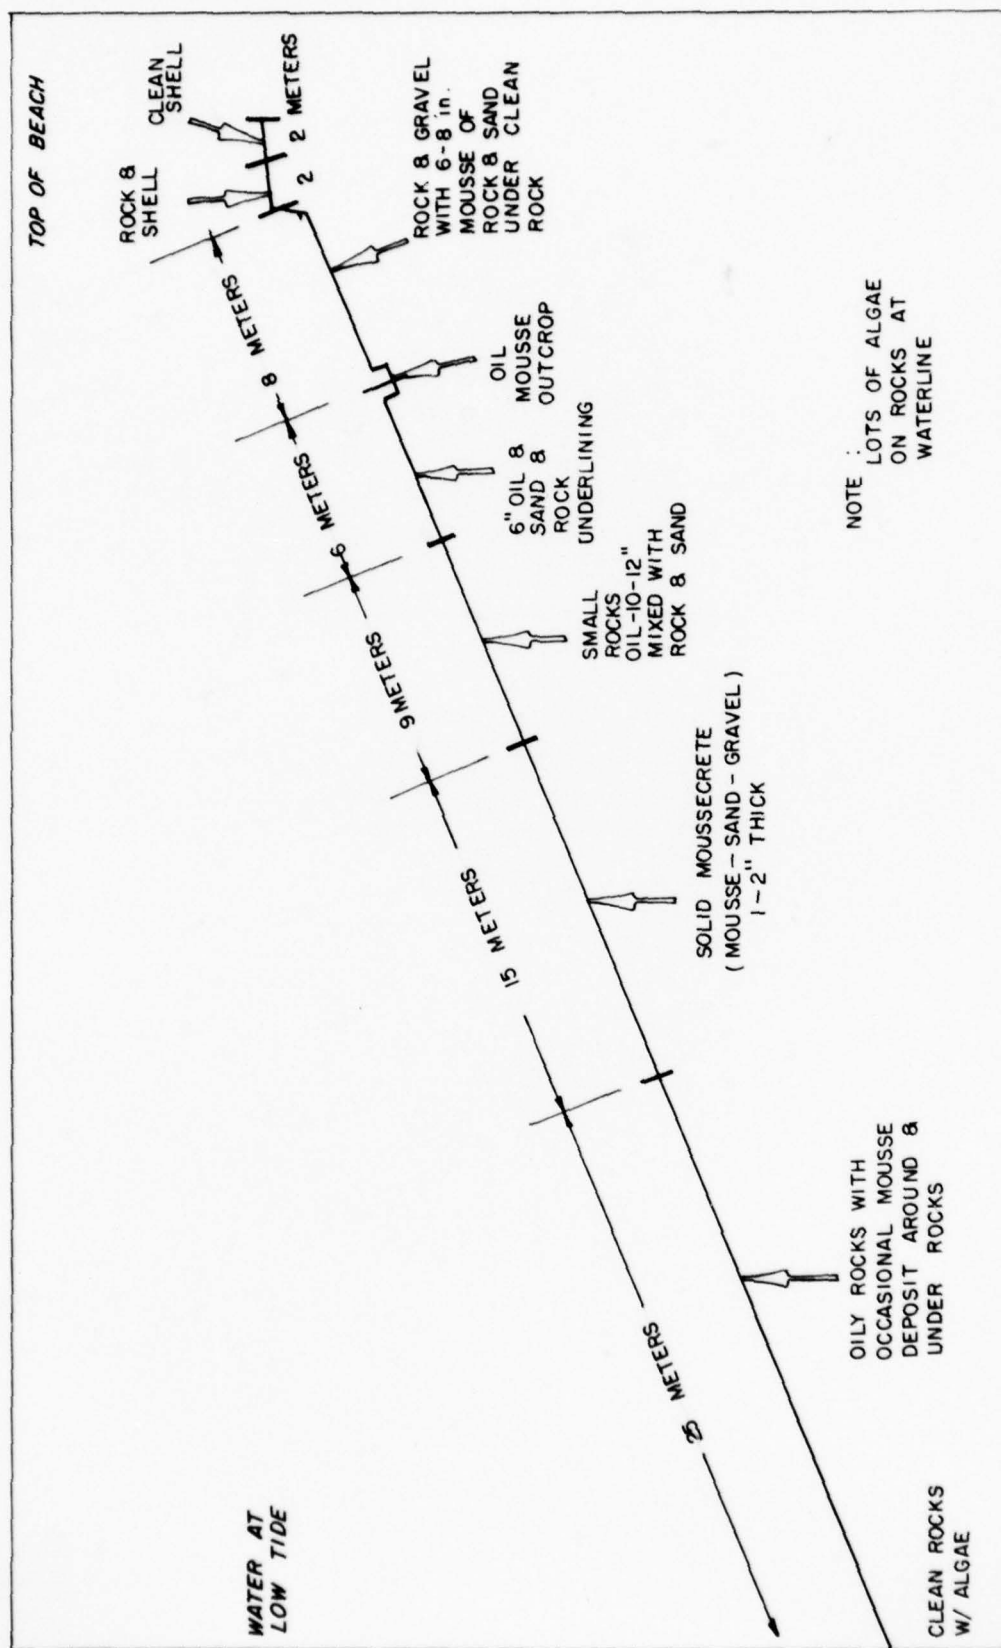
FIGURE 23

BEACH PROFILE BAHIA AZUL BEACH FACE

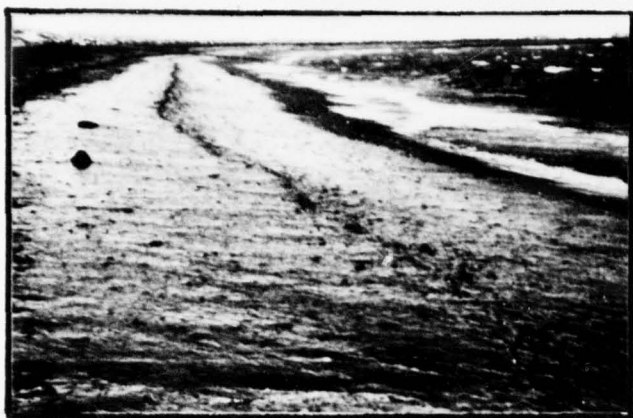
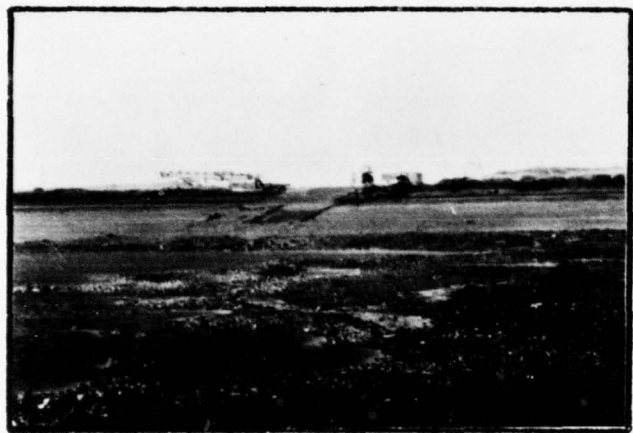
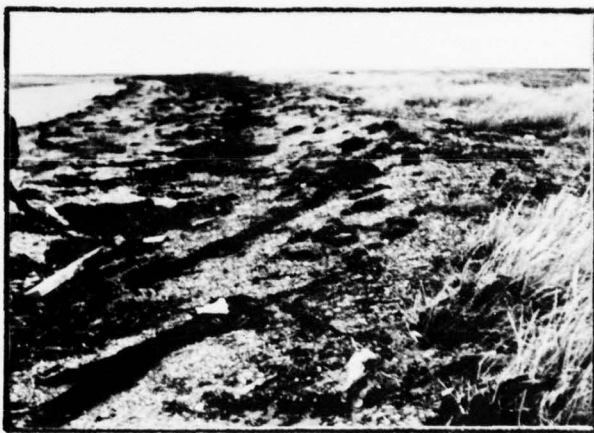
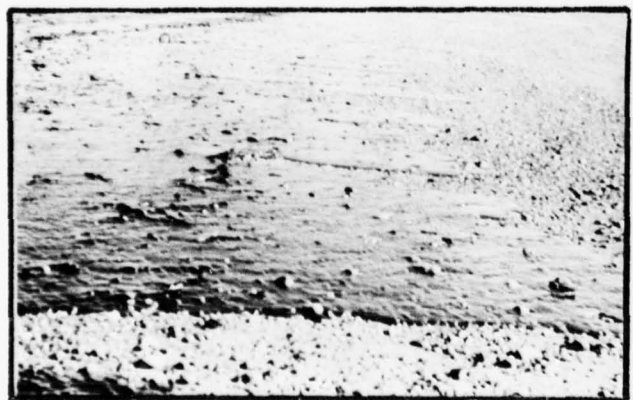
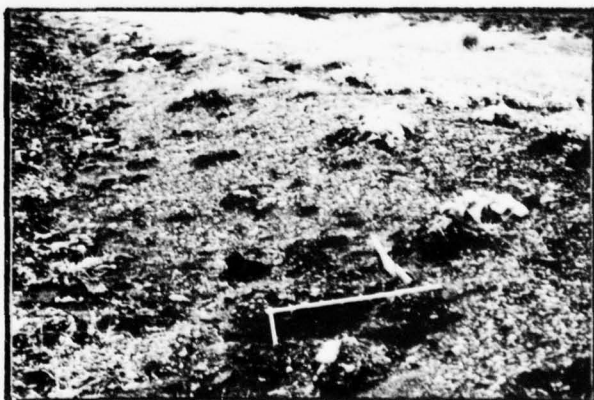
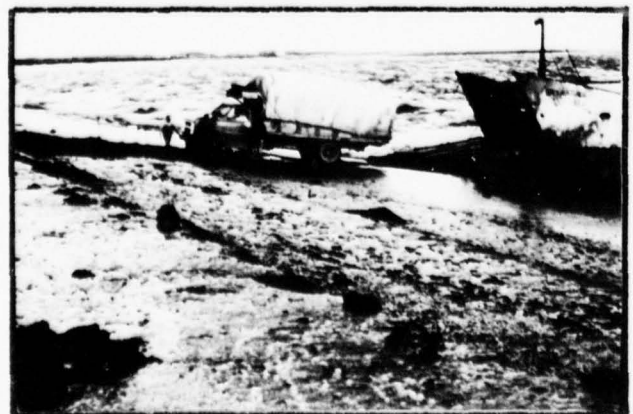
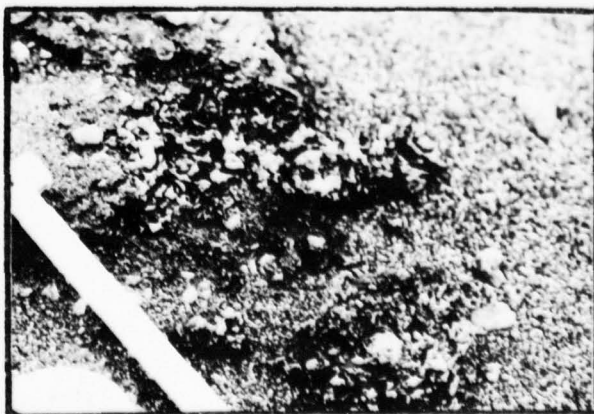
FIGURE 24

The study in January 1975 indicated substantially heavier deposits in the intertidal zone than in September 1974. The initial loading of the Espora beach top in late August and early September 1974 as compared to how it looked in January of 1978 is depicted in Figure 24. In Figure 24 Parts A, B, C and D the loading on the beach at both high and low tide may be noted.

- A - Espora beach top at time of the spill.
- B - Old Ferry Landing at Puerto Espora at low tide during the spill.
- C - Stranded oil draining down beach face during time of the spill.
- D - Ferry Unloading on oiled Espora beach.
- E - Weathered oiled beach top looking west at Espora in January 1978.
- F - Weathered oiled beach top looking east at Espora in January 1978.
- G - Close-up of weathered sediments at top of Espora beach.
- H

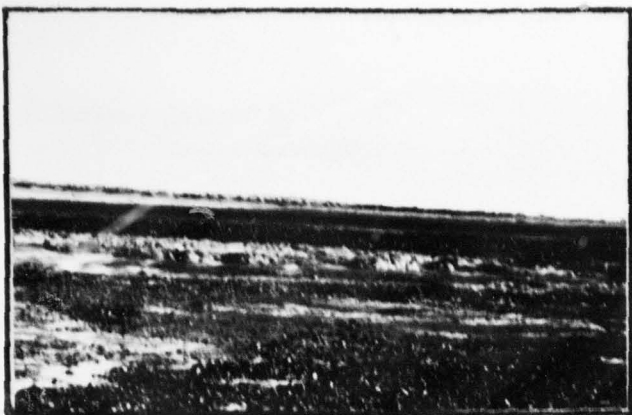
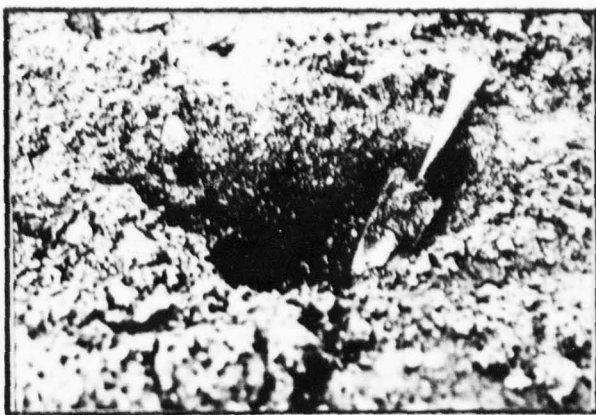
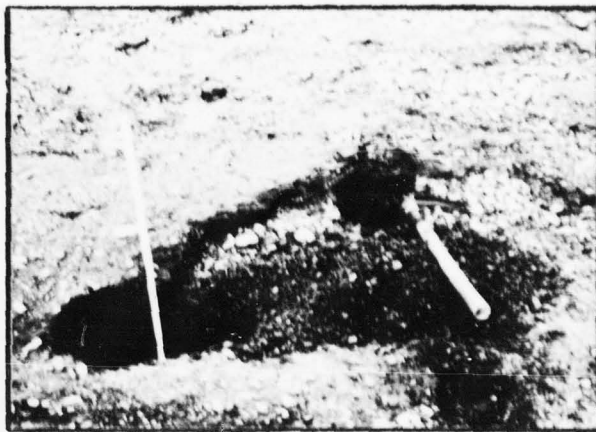
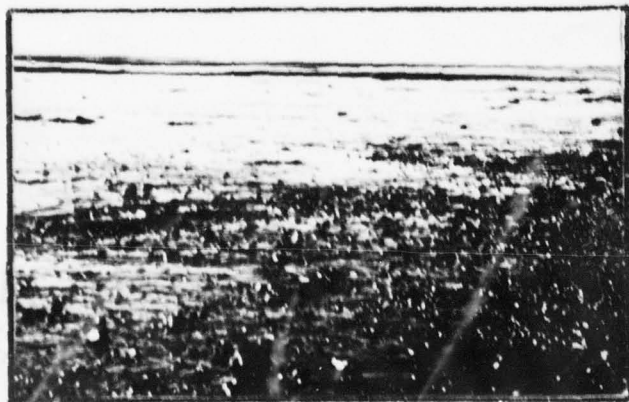
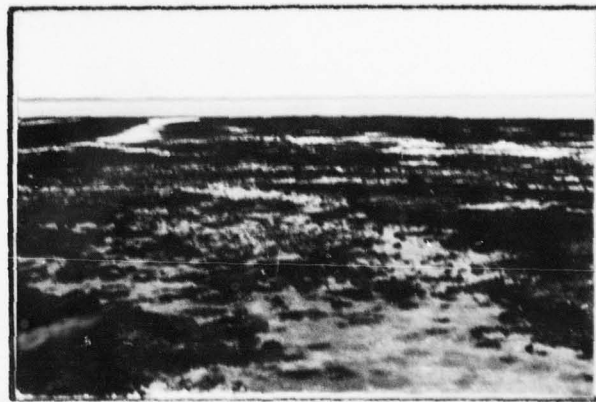
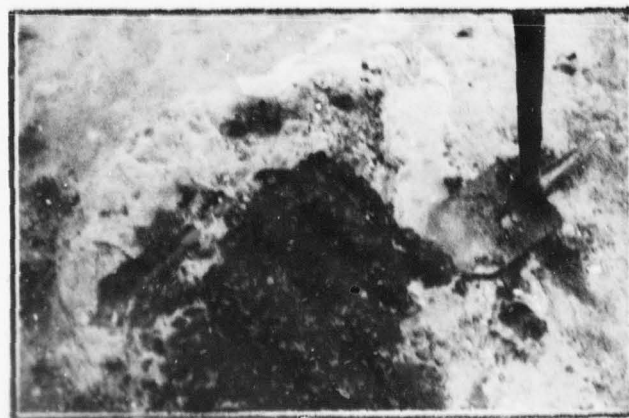
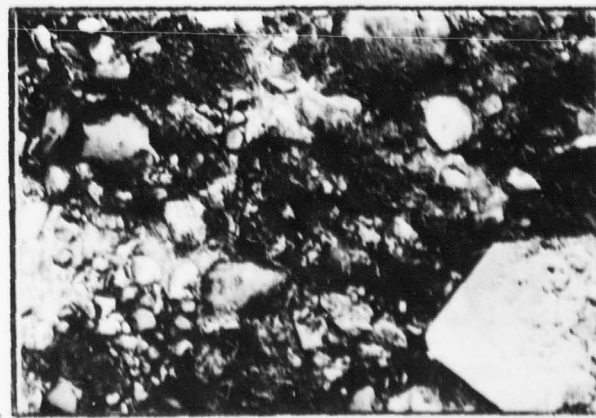
FIGURE 25

It is in the broad flat intertidal zone that the oiling at Espora was so dramatic. The sequence of events that led to this phenomenon are shown in Figure 25 Parts A, B and C.

It is believed that the rapid return of the tide in this area created a hydrostatic head over the stranded oil which forced it into the sediment before it could float or be washed to the surface. Much of the flat had mousse penetrating into the sediments from 5 to 10 centimeters (2 to 4 in) and in places it was over 30 centimeters (12 in) thick. Figure 25 Part E shows a measurement pit in the pavement in 1975 and Figure 25 Part F shows a similar pit in 1978. Since the sediments are covered with cold water much of the time and since the thick mousse contains much water, the oil in the pavements has weathered very little. The new pits yield the same brown mousse observed three years earlier. Figure 25 Parts G and H show additional views taken in 1978. In Part G the algal growth on the oiled sediments may be noted.

- A - Espora flat in late August 1974.
- B - Movement of oil into Espora area on September 2, 1974.
- C - Deposited oil in Espora Flat at low tide on September 2, 1974.
- D - Algae on oil surface and mousse under surface.
- E - Oiled sediment in Espora Flat on January 1975.
- F - Oiled sediment in Espora Flat in January 1978.
- G - Oiled Espora tidal flat looking seaward.
- H - Close-up of algae growing on oiled sediment.

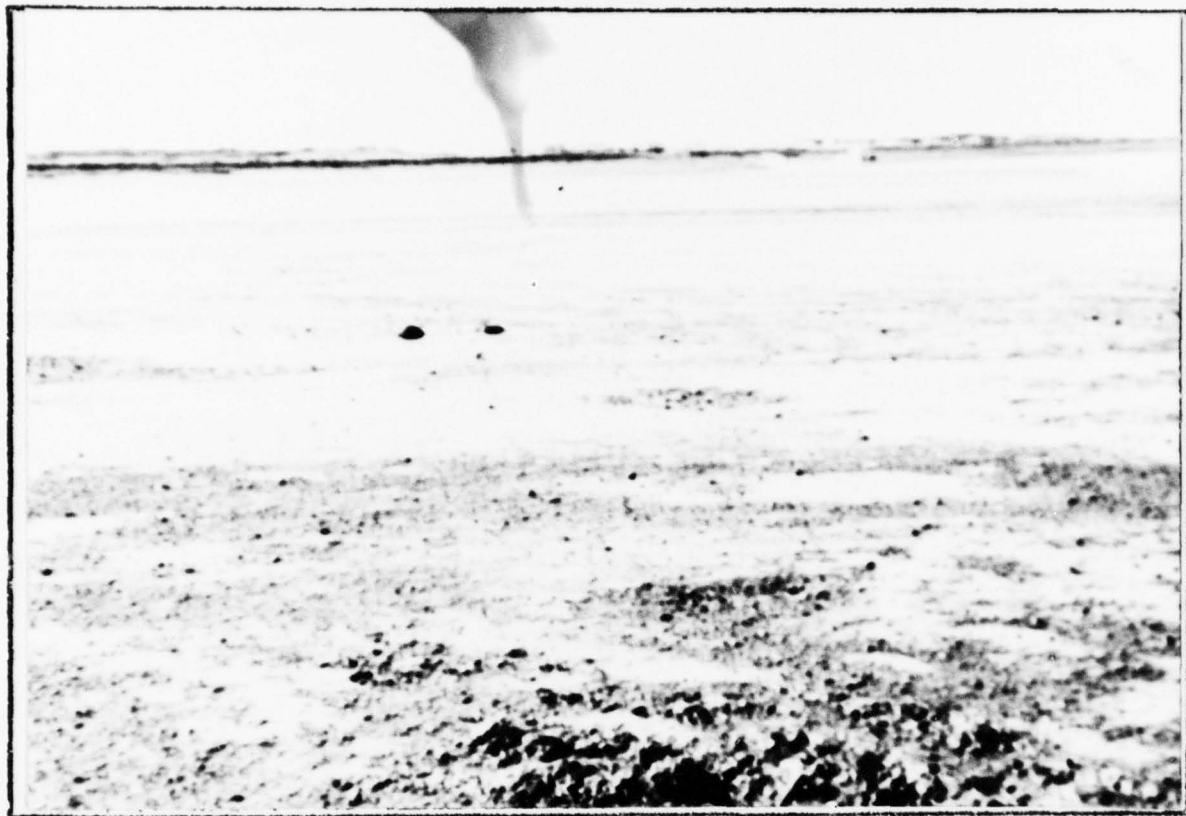
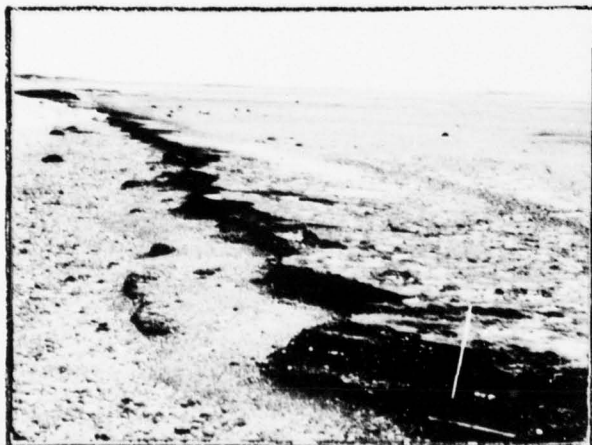
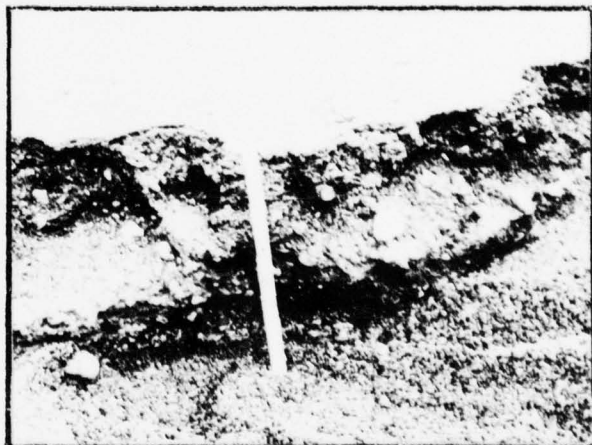
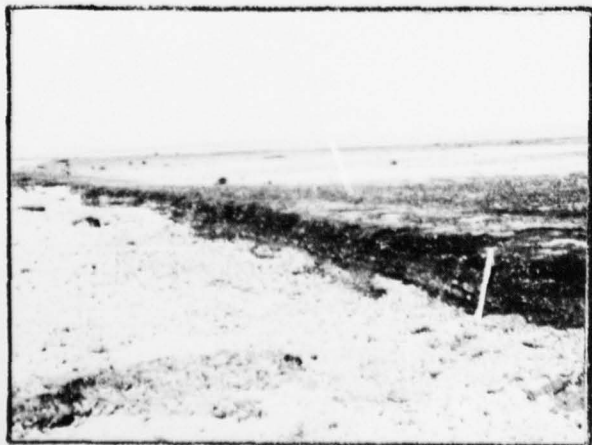
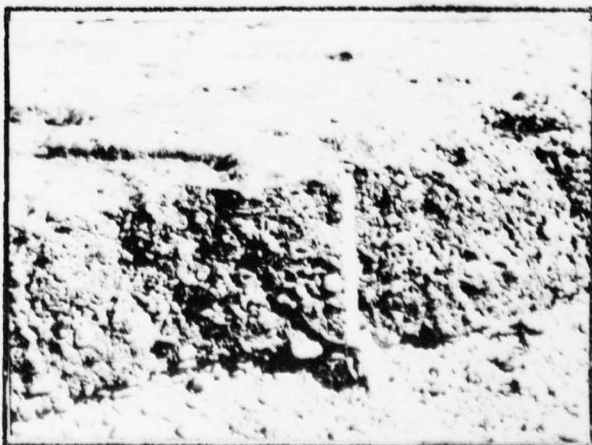
FIGURE 26

The dramatic aerial extent of the deposits may be noted in Figure 26 Part A and the depth of the pavement-like moussecrete may be noted in Figures 26 Parts B, C, D and E. These latter pictures were taken in 1977 and 1978 where the edges of the pavements are eroding.

- A - View along oiled tidal flat toward Old Ferry landing.
- B - Eroded edge of sediment at bottom of beach slope.
- C - Close-up of eroded edge showing 11 inch thickness.
- D - Additional close-up of eroded edge taken in January of 1978.
- E

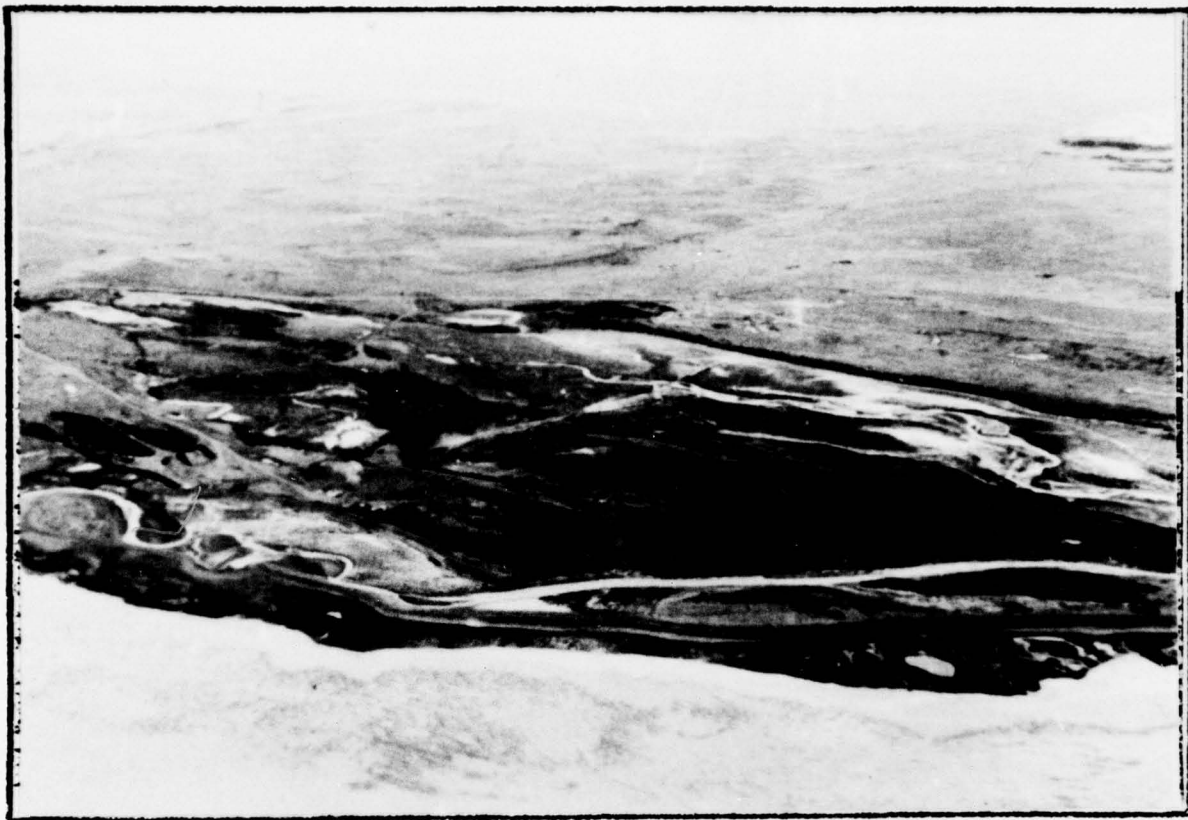
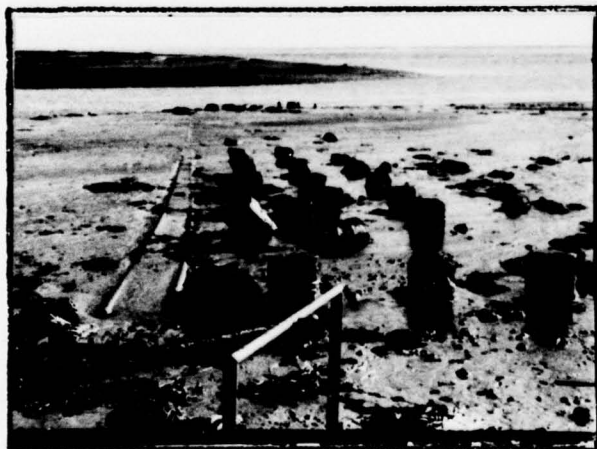
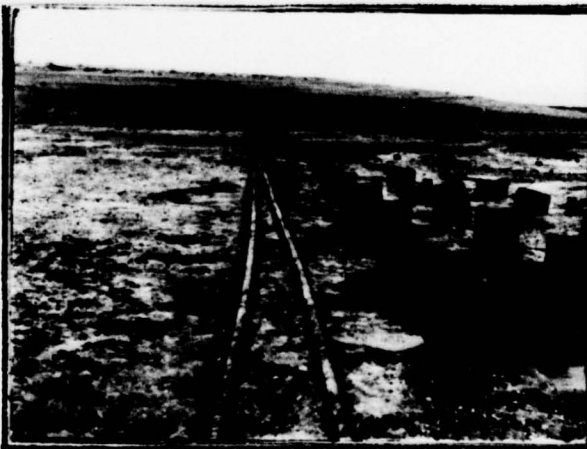
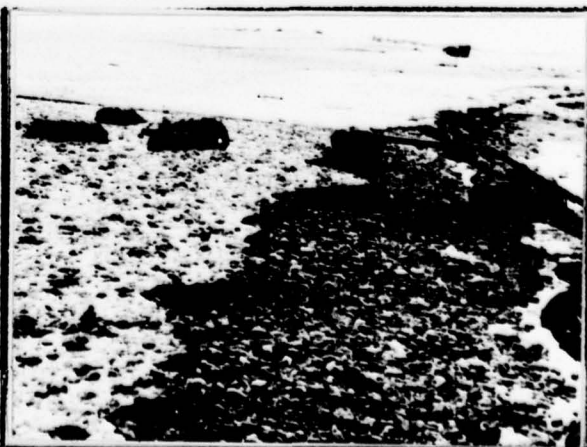
FIGURE 30

An oblique aerial view of the entrance area is shown in Figure 30 Part A. Figure 30 Parts B, C, D and E show views of an old pipeline and dock area at the West Estuary entrance. It is of interest to compare the depth of coverage in 1974 versus 1978. In 1978 the entire area along the pipe is still mousse covered, but the thickness has been reduced by weather and loss of water.

Figure 30 Part E shows the eroding lower edge of this deposit. It has only moved a few meters in the three and a half year period but does continually back oil into the West Estuary waters. The banks along the West Estuary were essentially paved with mousse in 1974. Figure 31 Part A shows an Environmental Protection Agency scientist viewing the paved north bank in January 1975.

- A - Aerial photograph of entrance to West Estuary at low tide.
- B - Oil drum area near mouth of West Estuary in August 1974.
- C - Aerial view of oil drum area in January of 1975.
- D - Oil drum area near mouth of West Estuary in January 1978.
- E - Eroding lower edge of oiled layer at oil drum area.

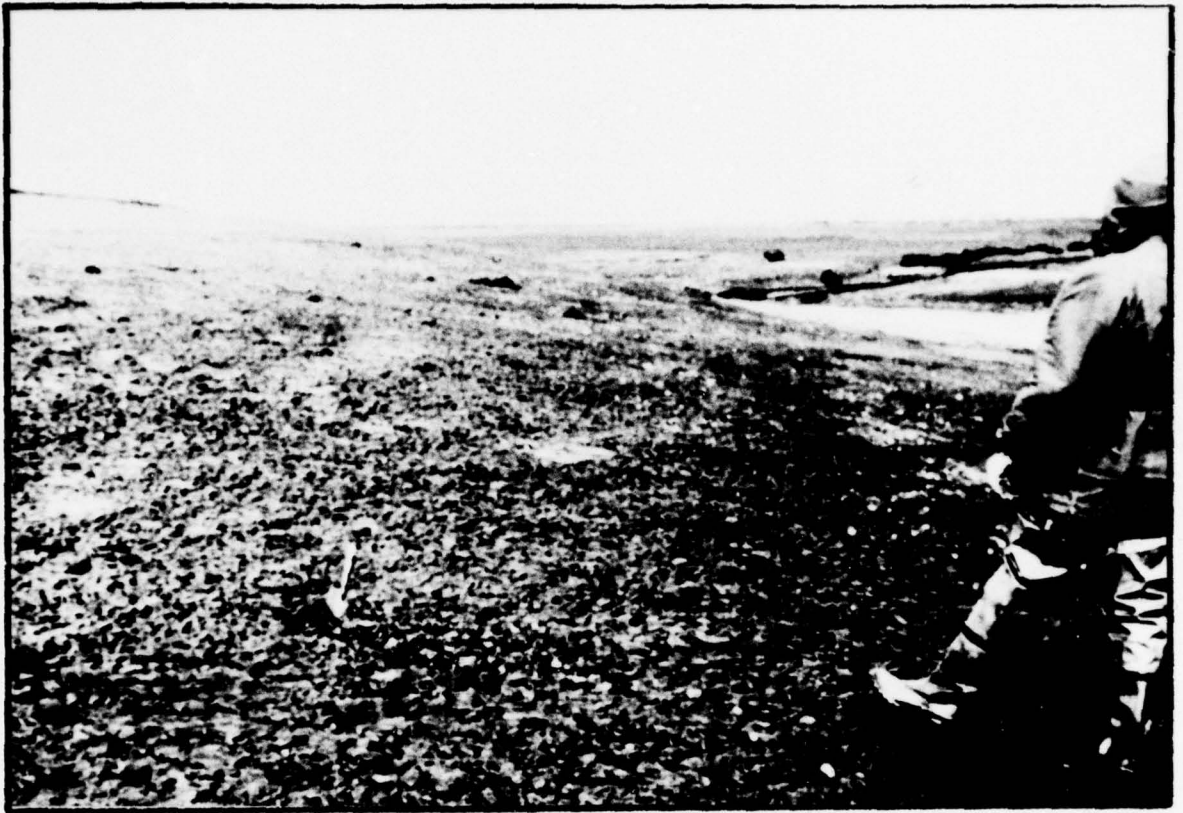
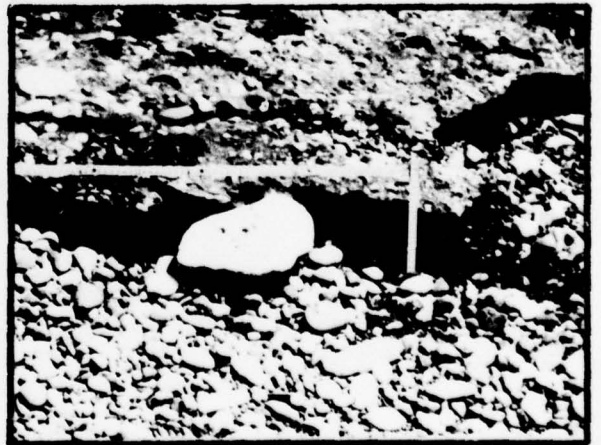
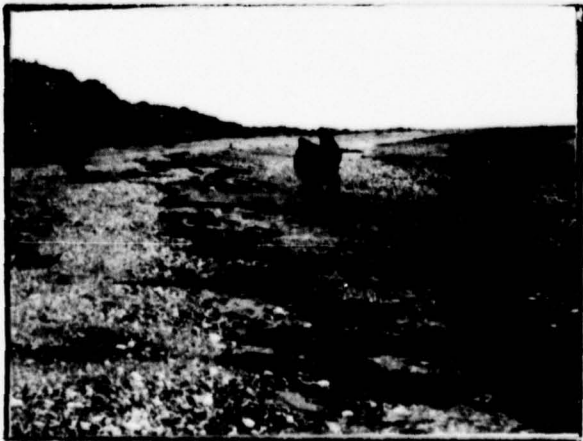
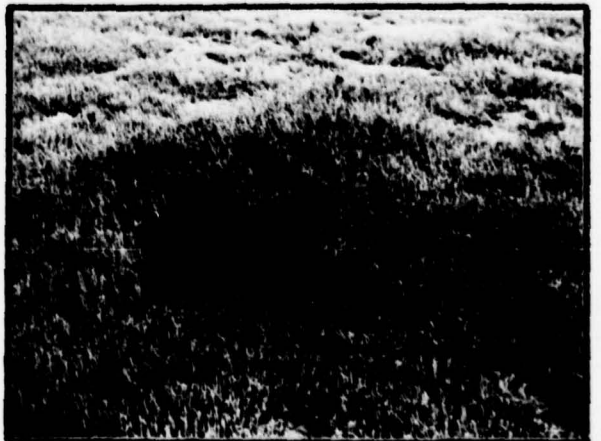
FIGURE 31

Figure 31 Parts B through D show views of the eroded and non-eroded areas in 1978 and a closeup of an eroding edge at the spring high tide level near the mouth where the limited erosion is taking place.

Figure 31 Part E shows a newly oiled area in a salicornia patch in 1978. This oil had leached from a patch of older oil under the influence of summer sun and high tide and been deposited in a heretofore uncovered area. Figure 32 Parts A, B, C and D show various views of stranded mousse on the salt marsh and mud flats of the West Estuary in 1974 and January 1975.

- A - Oiled north bank of West Estuary in January of 1975.
- B - Eroding upper edge of paved bank on South Shore.
- C - Another view of eroding upper edge.
- D - Close-up of eroding edge.
- E - Patch of *Salicornia* newly oiled by oil washed from previously oiled area on a warm day.

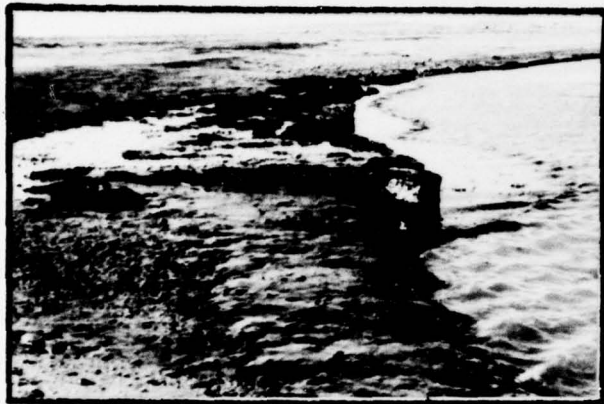
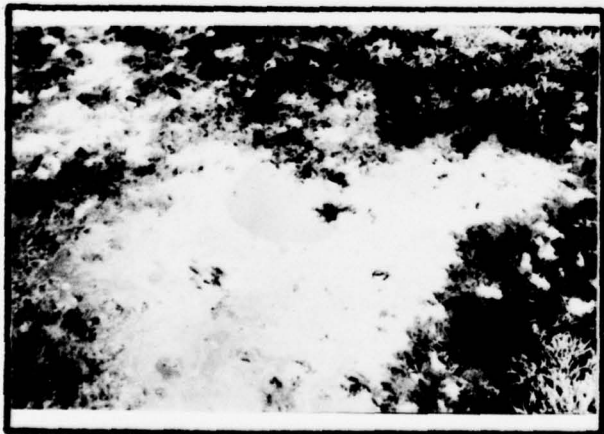
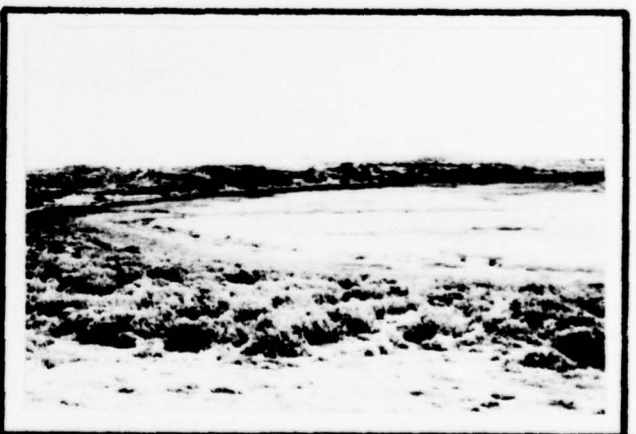
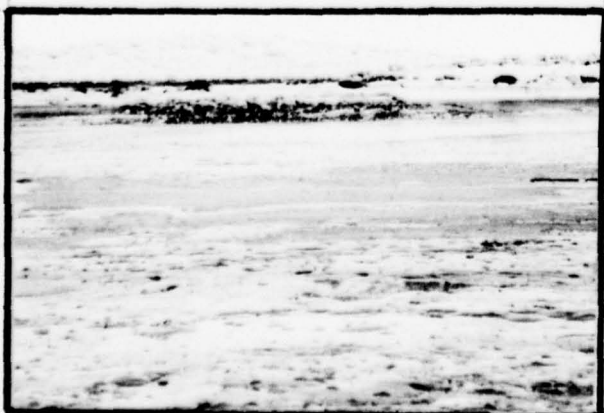
FIGURE 32

Further inland in the West Estuary are tidal flat areas originally covered with salicornia and large barren sand flats. Figure 32 Parts E, F, G, and H shows a sequence of photographs of one of these areas taken from 1974 through 1978.

It may be noted that the same oiled areas are evident in each of the photographs. The texture and sheen of the oiled areas have dulled from

- A - Oiled Salicornia area in tidal marsh.
- B - Oil stranded on mud flat inside West Estuary bend.
- C - Oiled Salicornia and pool of oil.
- D - Oil stranded on mud flat.
- E - West Estuary Marsh 8/74
- F - West Estuary Marsh 1/75
- G - West Estuary Marsh 1/77
- H - West Estuary Marsh 1/78

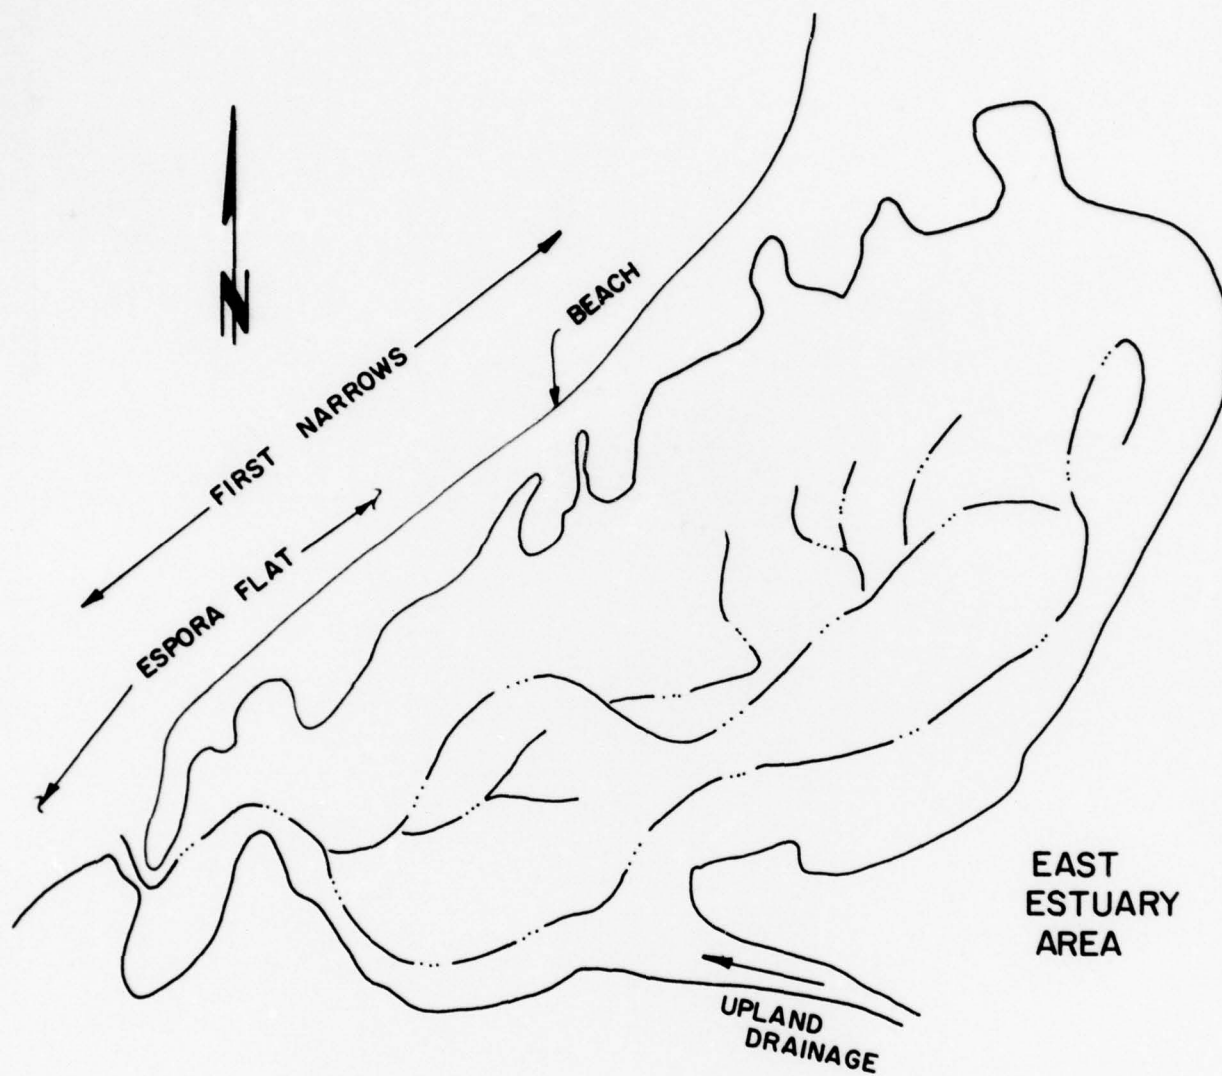
FIGURE 33  
AERIAL VIEW OF THE EAST ESTUARY FIRST NARROWS

The East Estuary is a winding, twisting estuary which splits into several channels. The estuary drains a flat basin covered with grass and salicornia. Figure 33 shows an aerial photograph of the East Estuary and the Espora Flat over which the estuary drains. Figure 34 shows oblique aerial photographs of the estuary. Part A is taken from the Narrows looking shoreward and Part B from the back of the estuary looking toward the First Narrows.

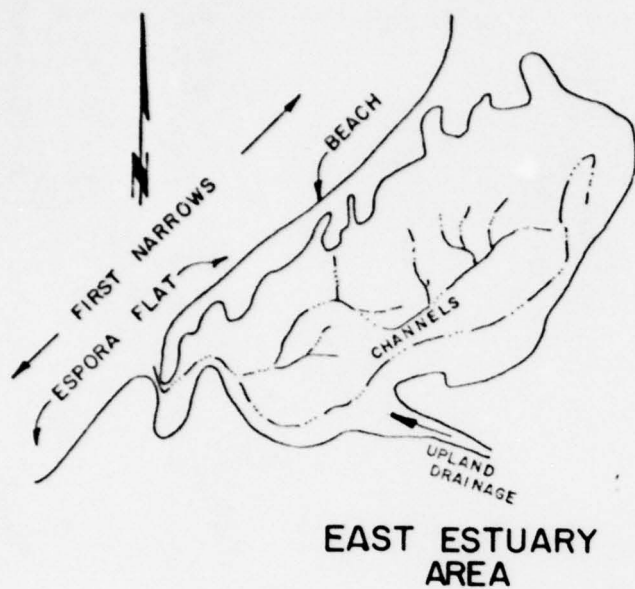
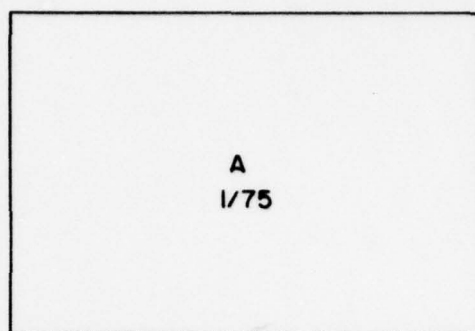
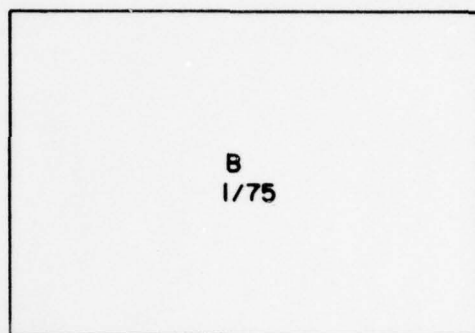
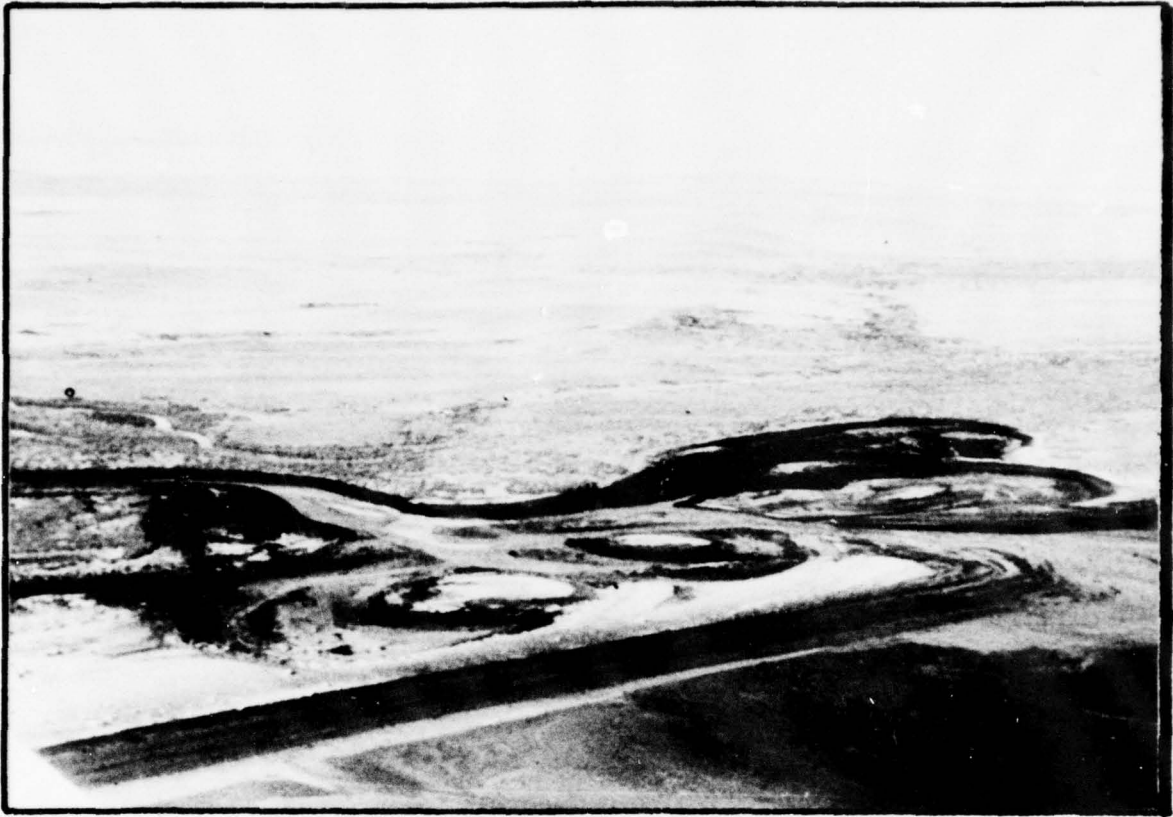
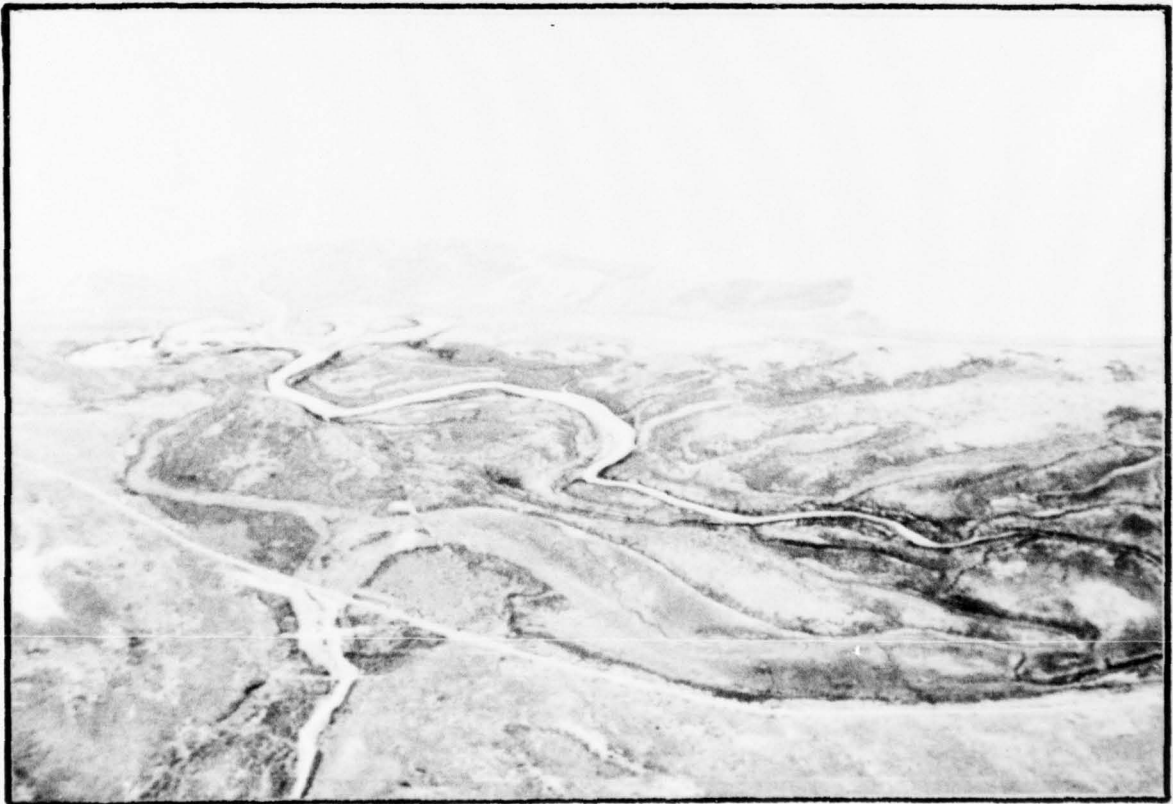
**FIGURE 34**

- A - Aerial view of East Estuary looking south.
- B - Aerial view of East Estuary looking northwest.

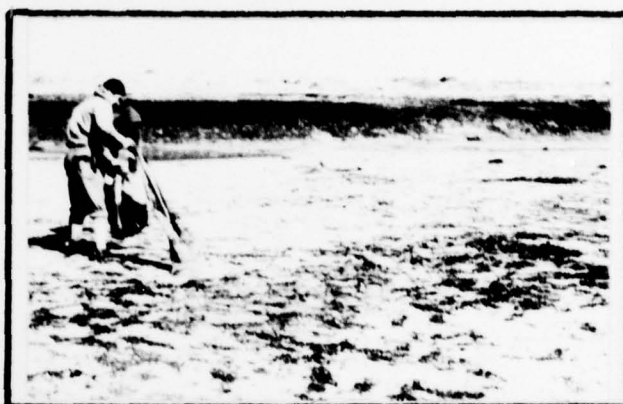
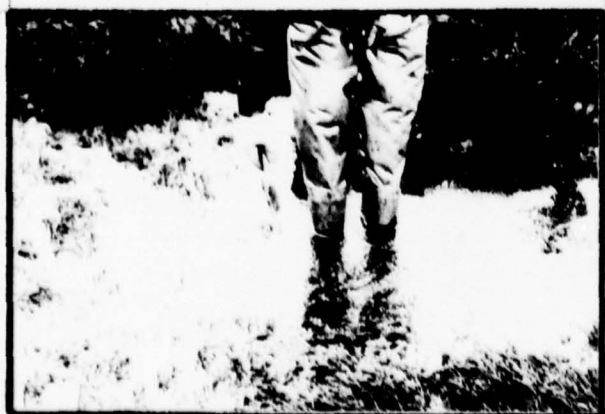
FIGURE 35

Figure 35 Parts A, B, C and D show views of the entrance area of the estuary in January 1975. In this area depressions and secondary channels were filled with mousse from a few centimeters to over 25 centimeters deep. The sediments of the channels and the channel banks were covered with mousse and mousse up to several centimeters thick. Figure 35 Parts E, F, G and H show views of this area in 1977. The area has changed very little since originally oiled. Entire areas are grotesquely black with no vegetation recovering. Liquid mousse remains in depressions and the channel bottoms are paved with moussecrete from 8 to 15 centimeters

The surface of the oil has blackened and in some cases algae and sediment form a thin film on the surface which dulls the appearance. Underneath, however, soft mousse is found everywhere.

- A - Aerial photograph of entrance area.
- B - Bank of East Estuary near mouth.
- C - Pooled oil near the entrance.
- D - Oil in shallow depression near entrance.
- E - Oiled basin near the entrance channel.
- F - Oiled bottom of a bend in the East Estuary.
- G - Close-up of oiled surface.
- H - Eroding edge of oiled sediments.

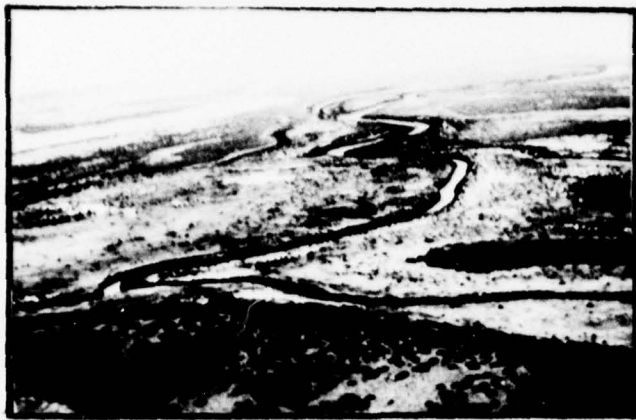
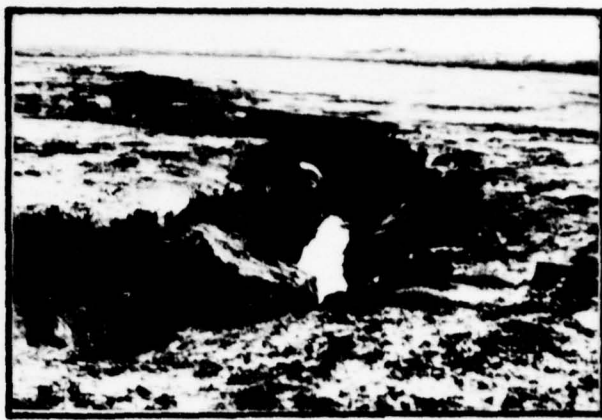
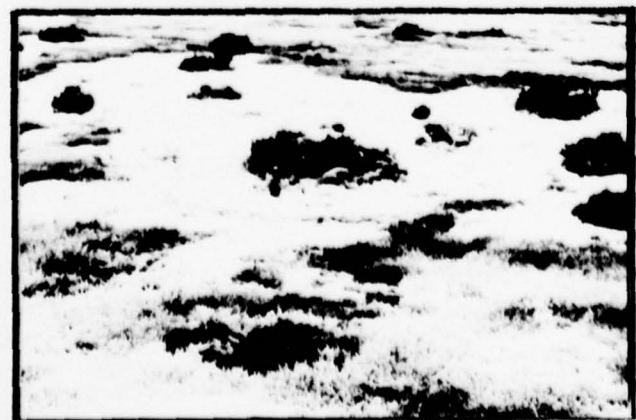
FIGURE 36

The estuary channels from about one kilometer inland were reported completely filled with floating mousse to the ends of the smallest channels in the system in January 1975. The channels were estimated at that time to have from 20 to 30 centimeters (8 to 12 in) or more of floating mousse trapped in it. The mousse would rise and fall with high spring tides and recoat the channel walls and vegetation. These channels are shown in Figure 36 Parts A, B and C.

The mousse had been flushed from the channels by January of 1976, but the flat areas between channels and the channel bank as shown in Figure 36 Part D in 1975 and Parts E, F, G and H in 1977 and 1978 remained heavily oiled. This liquid mousse or oil on the surface remains in a soupy liquid form which has changed little in the three and a half years since the spill. Only in the areas where the mousse was not thick has the deposit thickened and hardened. This area will probably have evidence of the METULA spill for 15 to 20 years unless it is ultimately cleaned up.

- A - Aerial view of inland channels showing oil on channel banks.
- B - Close-up of channel edges showing oiled vegetation.
- C - Thick pool of oil remaining in channel five months after the spill.
- D - Isolated oiled vegetation on tidal grass flat.
- E - Oiled channel at later date.
- F - Oiled vegetation on banks 3 1/2 years after the spill.
- G - Oiled channel 3 1/2 years after the spill.
- H - Oiled pool on tidal grass flat 3 1/2 years after the spill.

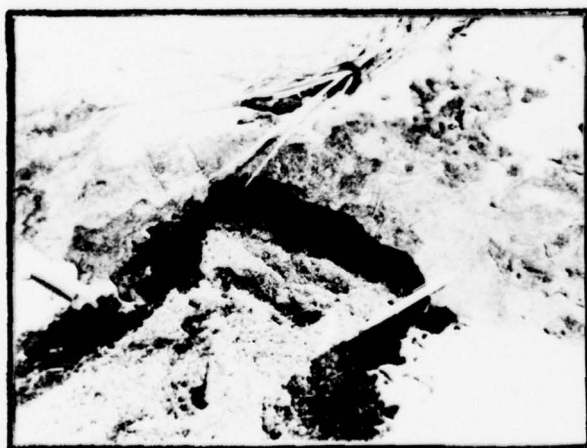
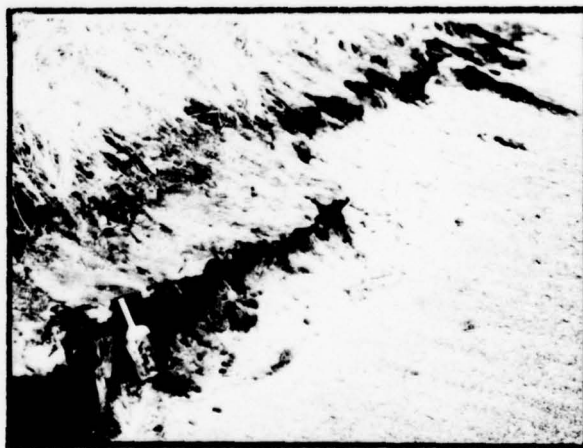
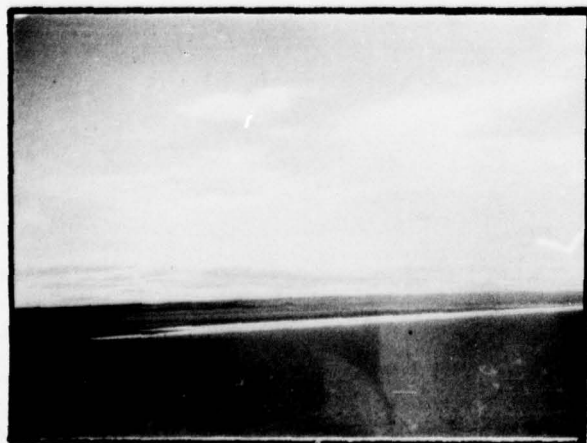
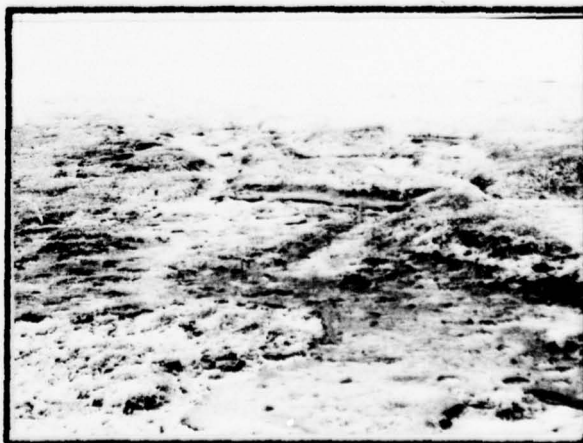
FIGURE 37

The intertidal zone in Punta Anegada is identically the same as the Puerto Espora area. The amount of oil on the shore fell off rapidly as one proceeds several kilometers east of Punta Anegada at the time of the spill. Figure 37 Part A shows a typical section of this beach line in January of 1975. At that time a 2-to 4-meter (6-12 ft) zone of exposed mousse was observed on the surface and an area of covered mousse and oiled rocks was observed down the beach slope. As shown in Figure 37 Part B and D by 1977 this had eroded to an occasional crust of weathered oil and sand mixture at the top of the beach line.

Further east is a broad flat intertidal area west of Punta Catalina. This run appeared to have a heavy oil coating from the air at the time of the spill as shown by the aerial photograph in Figure 37 Part C but only this was probably a wide sheen of fresh oil that was photographed.

Investigation in January of 1975 showed only occasional oiled areas at the high tide zone as shown in Figure 37 Part D.

- A - Oil at top of beach east of Punta Anegada.
- B - Weathered oil at top of beach east of Punta Anegada.
- C - Pooled oil sheen southwest at Punta Catalina.
- D - Weathered oil crust at top of beach east of Punta Anegada.
- E - Weathered oil at top of broad beach southwest of Punta Catalina.
